RICS
HomeBuyer Report ●●●

Property address

Client's name

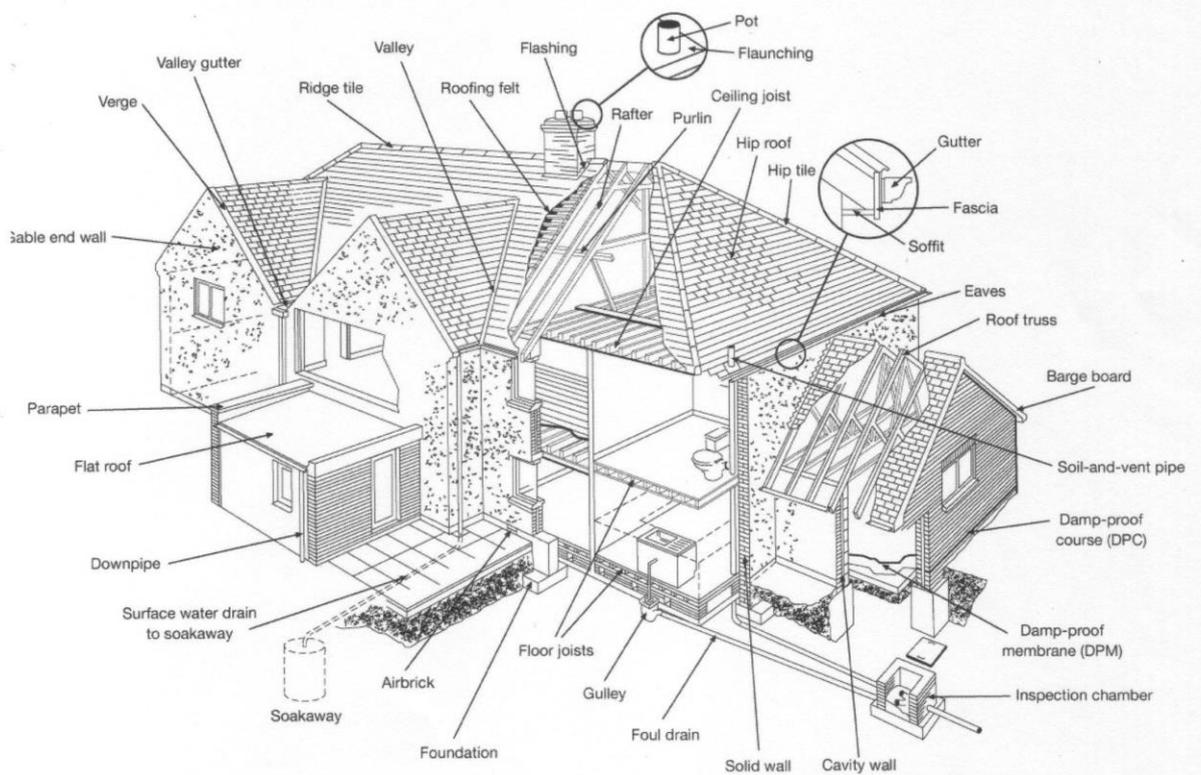
Typical house diagram

This diagram illustrates where you may find some of the building elements referred to in the report
